Wild Dog and Kangaroo Exclusion Fencing – a case study at “Banff Downs”, Morven

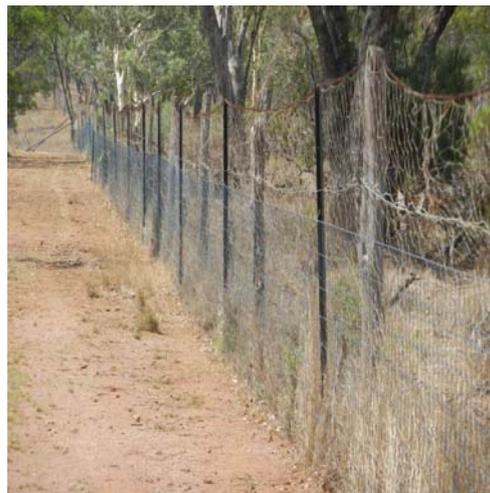
Photo 3: Fence 1 - The existing wild dog netting was tied to the new steel pickets

- Fencing materials cost \$2300/km
- Barbed wire was used from old existing fence
- The barbed wire was tied at the top of the post
- Plain wire was put at the bottom to strengthen the Stocksafe™ wire
- The existing dog netting was tied to the steel pickets where possible
- 10 metre spacing's between steel pickets
- In-line strainer posts are 800 metres apart
- Total height of new wire is 115cm, but the actual fence height varies due to the higher old wild dog netting fence

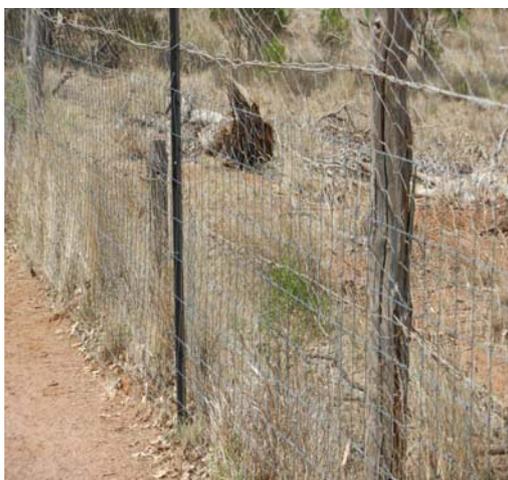
Photo 4: Fence 1 - The new fence was run alongside and tied to the existing old wild dog netting fence

- 2 different fences have been constructed, Fence 1 is an old dog netting fence with new wire run next to it and Fence 2 is a totally new fence

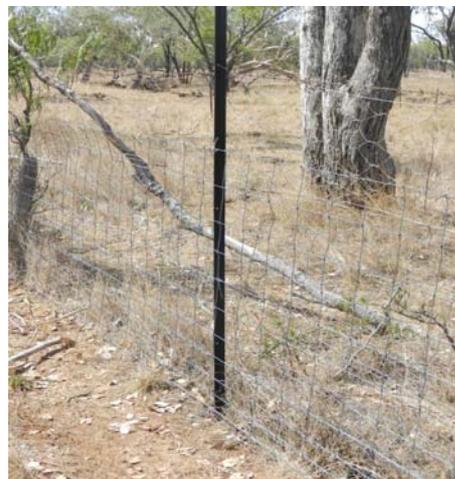
Photo 5: Fence 1 - A plain wire was run along the bottom of the fence for extra strength

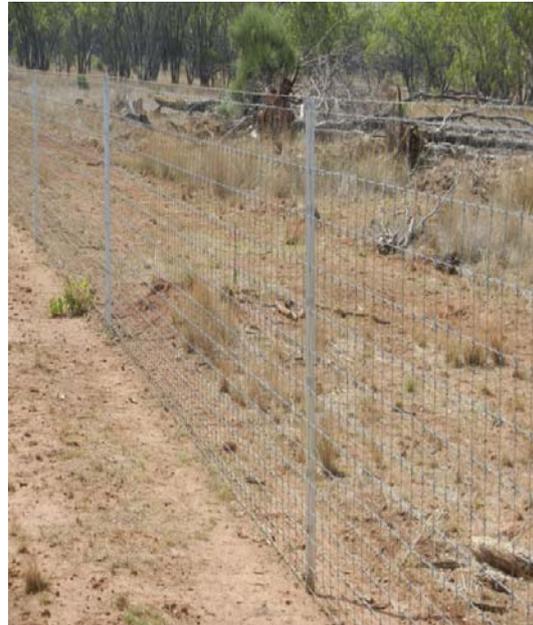
Photo 6: Fence 2 – Total height of the fence is 150cm

- **Materials used**
 - Fixed Knot™ wire which is 150cm high, with 14 horizontal running wires and 15cm gaps between the vertical wires
 - 1 barbed wire
 - 1 plain wire
 - 210cm Clipex™ steel pickets
- **Cost**
 - Fence materials cost \$4000/km
 - All material used in this fence were new
- 1 barbed wire at the top and 1 plain wire at the bottom to help strengthen the Fixed Knot™ wire
- 8 metre spacing's between steel pickets
- In-line strainer posts are 800 metres apart
- Total height of the fence is 150cm

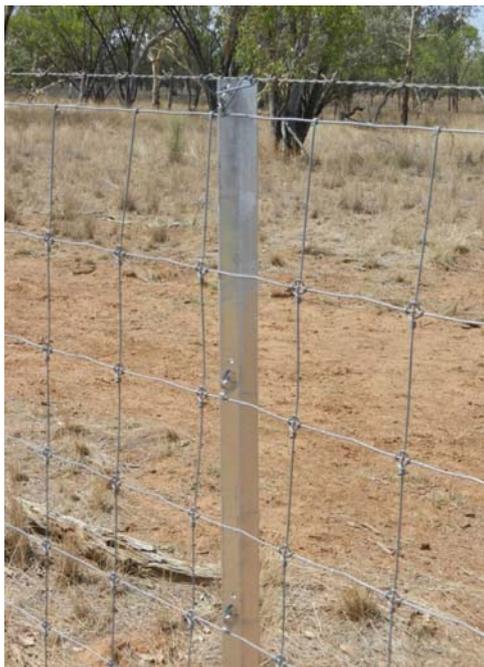
Photo 7: Fence 2 – 1 barbed wire at the top of the fence

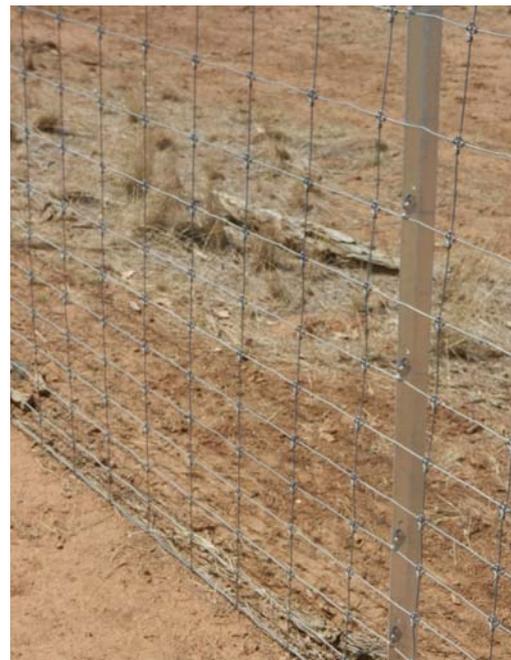
Photo 8: Fence 2 – Clipex™ post were used which made it easy to attach the wires

- Would recommend using a bottom barbed instead of plain wire for effectiveness, however a plain wire was used on Banff Downs as it fit into the Clipex™ post better with the Fixed Knot™ wire

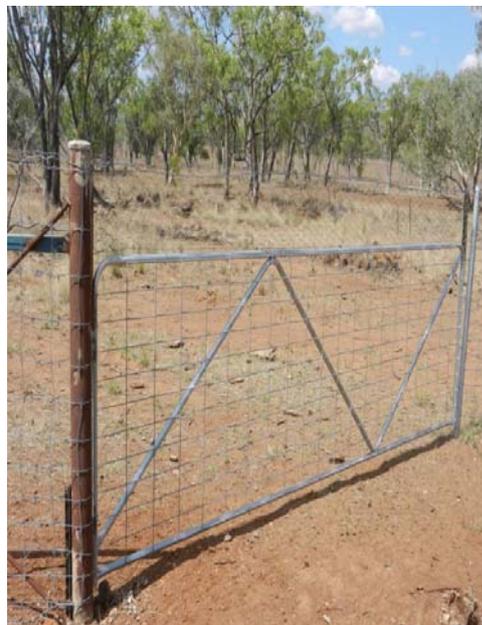
Photo 9: The gates needed netting to be added on top of the gates for extra height

- The gates used needed extra height, so some 30cm chicken wire was attached to the top of the gate
- Originally used a wire that only had 8 horizontal wires, but this was not effective as animals (e.g. piglets) could stretch the wire and make bigger holes to get through

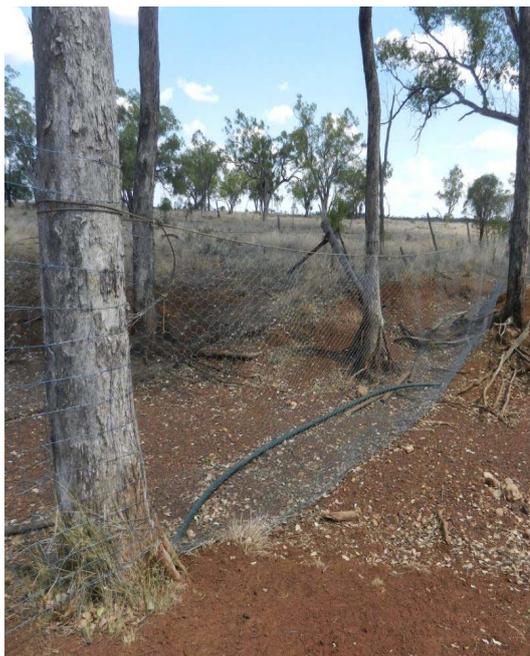
Photo 10: Cable was suspended between 2 trees and the netting was tied to the cable

- The fence crosses a creek a number of times which can cause problems after floods
- In the creek crossings netting was suspended from a cable secured between 2 trees, it was essential the netting was long enough to overhang along the ground to stop animals getting through after flooding

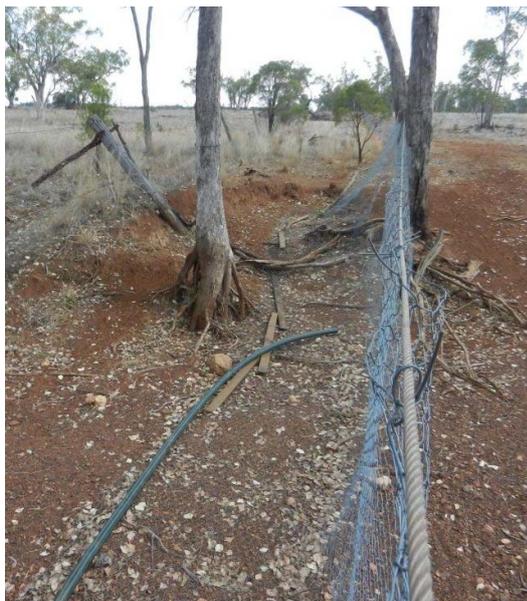
Photo 12: The netting is left long to overhang along the ground to stop animals getting through after flooding
